2.0 ENVIRONMENTAL FRAMEWORK

2.1 REGIONAL CONTEXT

This section summarizes the analysis of site opportunities and constraints phase of the project, which assessed the current physical characteristics of the Greenway and the opportunities and limitations for future uses, improvements, and restoration projects. Mapping was based on GIS data compiled by Brown County and City of Green Bay Public Works, and the most current Greenway base map file from City of Green Bay Parks, Recreation, and Forestry. All aerial photography used for the analysis graphics was taken in 2005. Habitat information was included from the Baird Creek Greenway Ecological Assessment and Management Plan completed in 2003. The diagrams also incorporated non-digital information from the Brown County Comprehensive Plan, a site walk with BCPF Board members, a map of Baird Creek ski trails from the City Parks Department, and a hand-drawn map of existing trails and trail work by Jonathan Viste of WORBA.

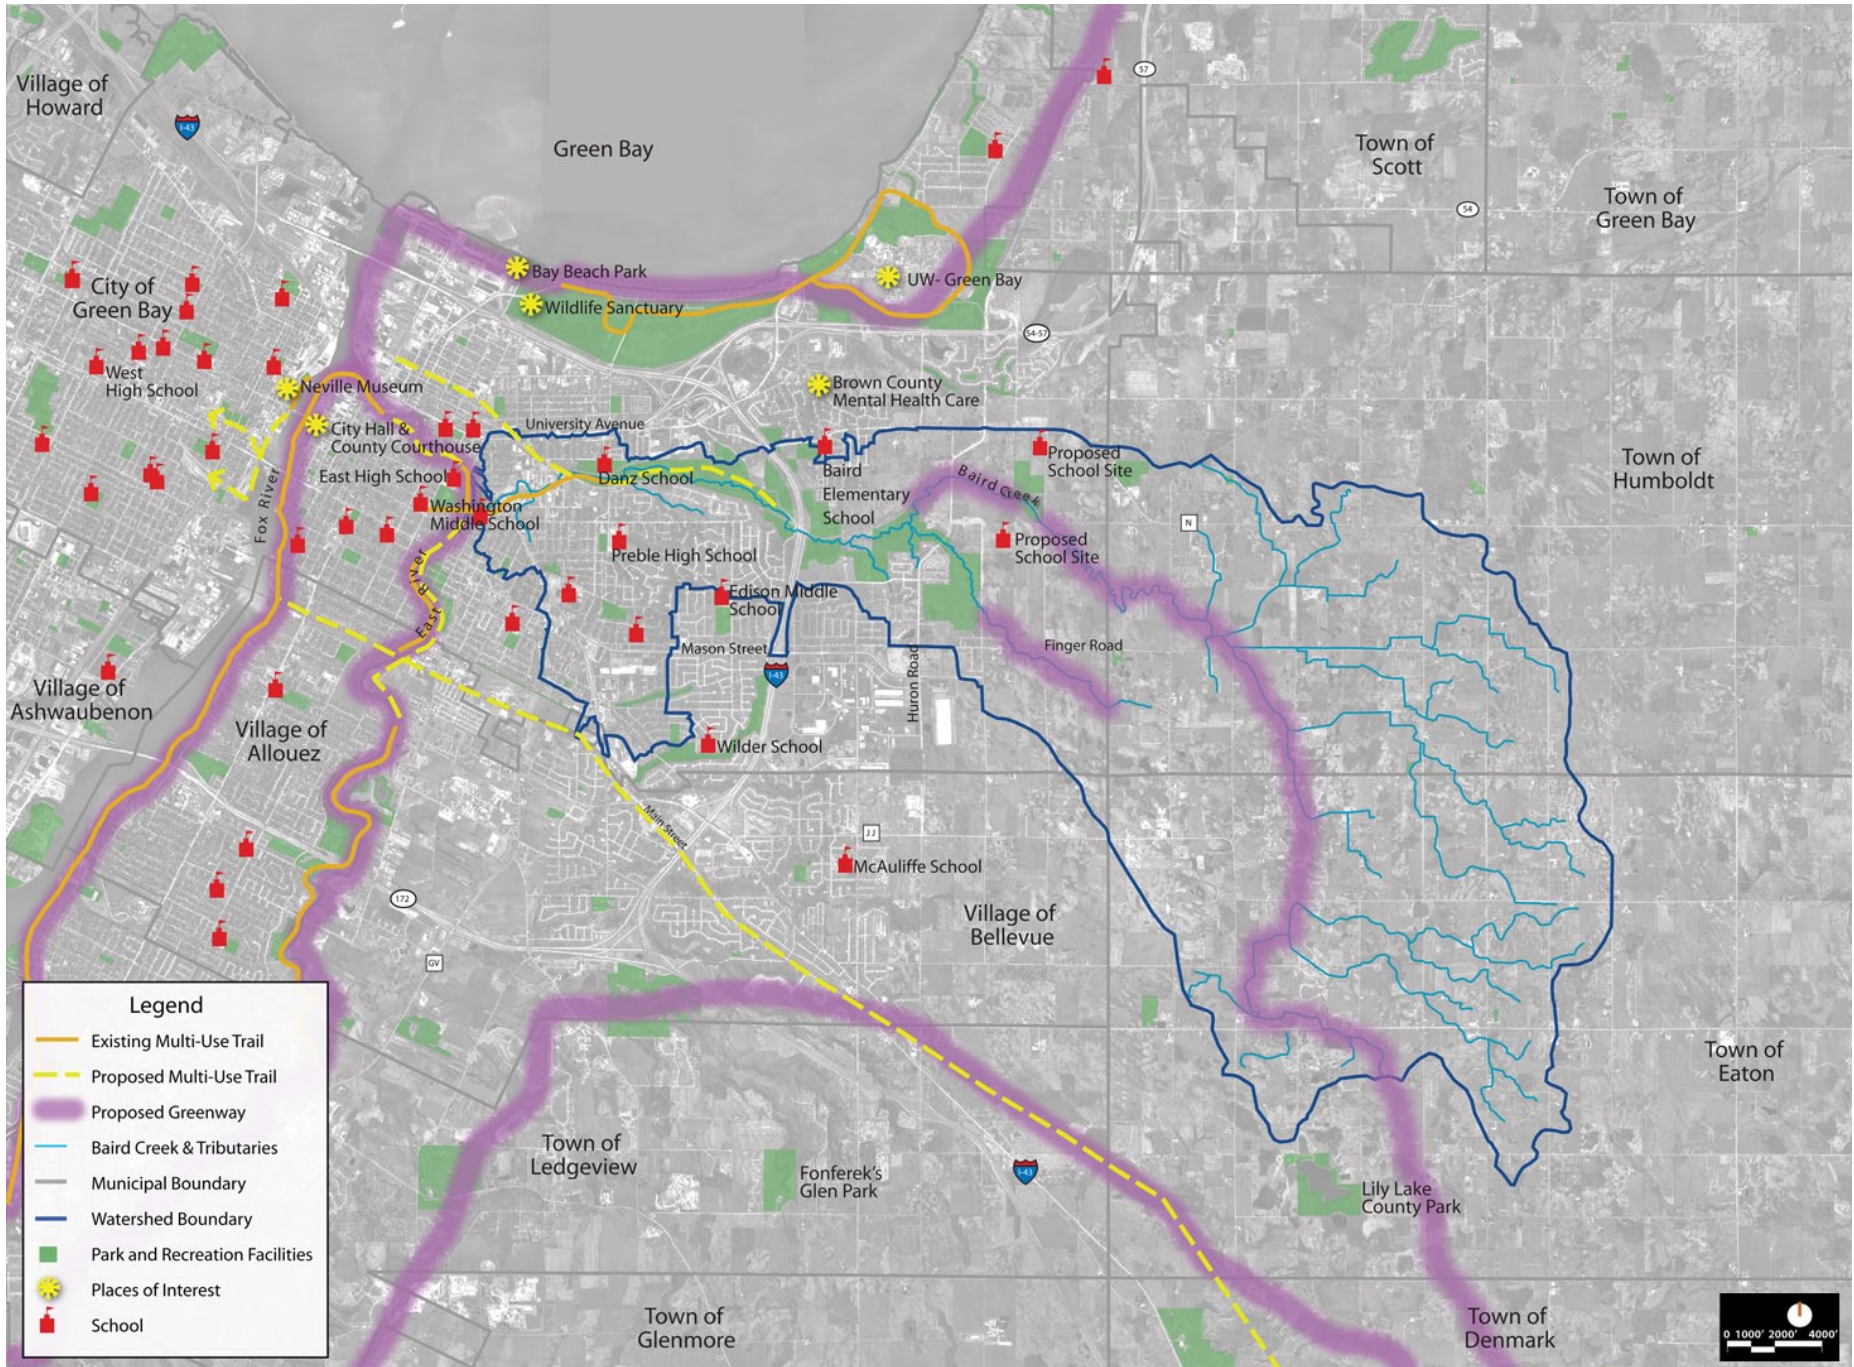
REGIONAL CONTEXT DIAGRAM

The Regional Context Diagram establishes the site within its cultural and natural setting, showing connections with other green spaces, watersheds, population centers, cultural amenities, and other facilities. As shown by the diagram on the facing page, Baird Creek flows west from headwaters in the Towns of Humboldt and Eaton through the City of Green Bay to empty into the East River just to the east of downtown. It is part of the Lower Fox River drainage basin, a major contributor to Lake

Michigan and the Great Lakes. The Greenway is located along Baird Creek within the Green Bay City limits, spanning both sides of Interstate 43. As a large environmental corridor surrounded by urban land use, the Greenway offers a rare opportunity for city residents to experience nature only a short distance from their homes.

Multiple connections to other open spaces are possible from the Baird Creek Greenway. Trail connections could extend north along Danz Avenue to the Bay Beach Wildlife Sanctuary and north along Huron/Bay Settlement Road to the UW-Green Bay Cofrin Arboretum. A multi-use trail is also planned within the Greenway that will provide an alternative transportation route to downtown Green Bay, as well as connections to the East River and Fox River Trails. Future greenways identified in the Brown County Comprehensive Plan could also link southeast to Lily Lake County Park and north along the Niagara Escarpment. Trail loops throughout these Greenways would provide wonderful recreational opportunities for the region.

The information collected from these sources was compiled into two types of summary graphics: (1) a Regional Context Diagram and (2) Site Analysis Diagrams. Upon evaluation of the regional context and site analysis, opportunities and limitations for the site were summarized graphically into Environmental Framework Diagrams. Finally, additional information was acquired through a qualitative assessment of the habitats between Huron and Grandview Roads to guide the placement of trails and other facilities as the Greenway expands upstream.

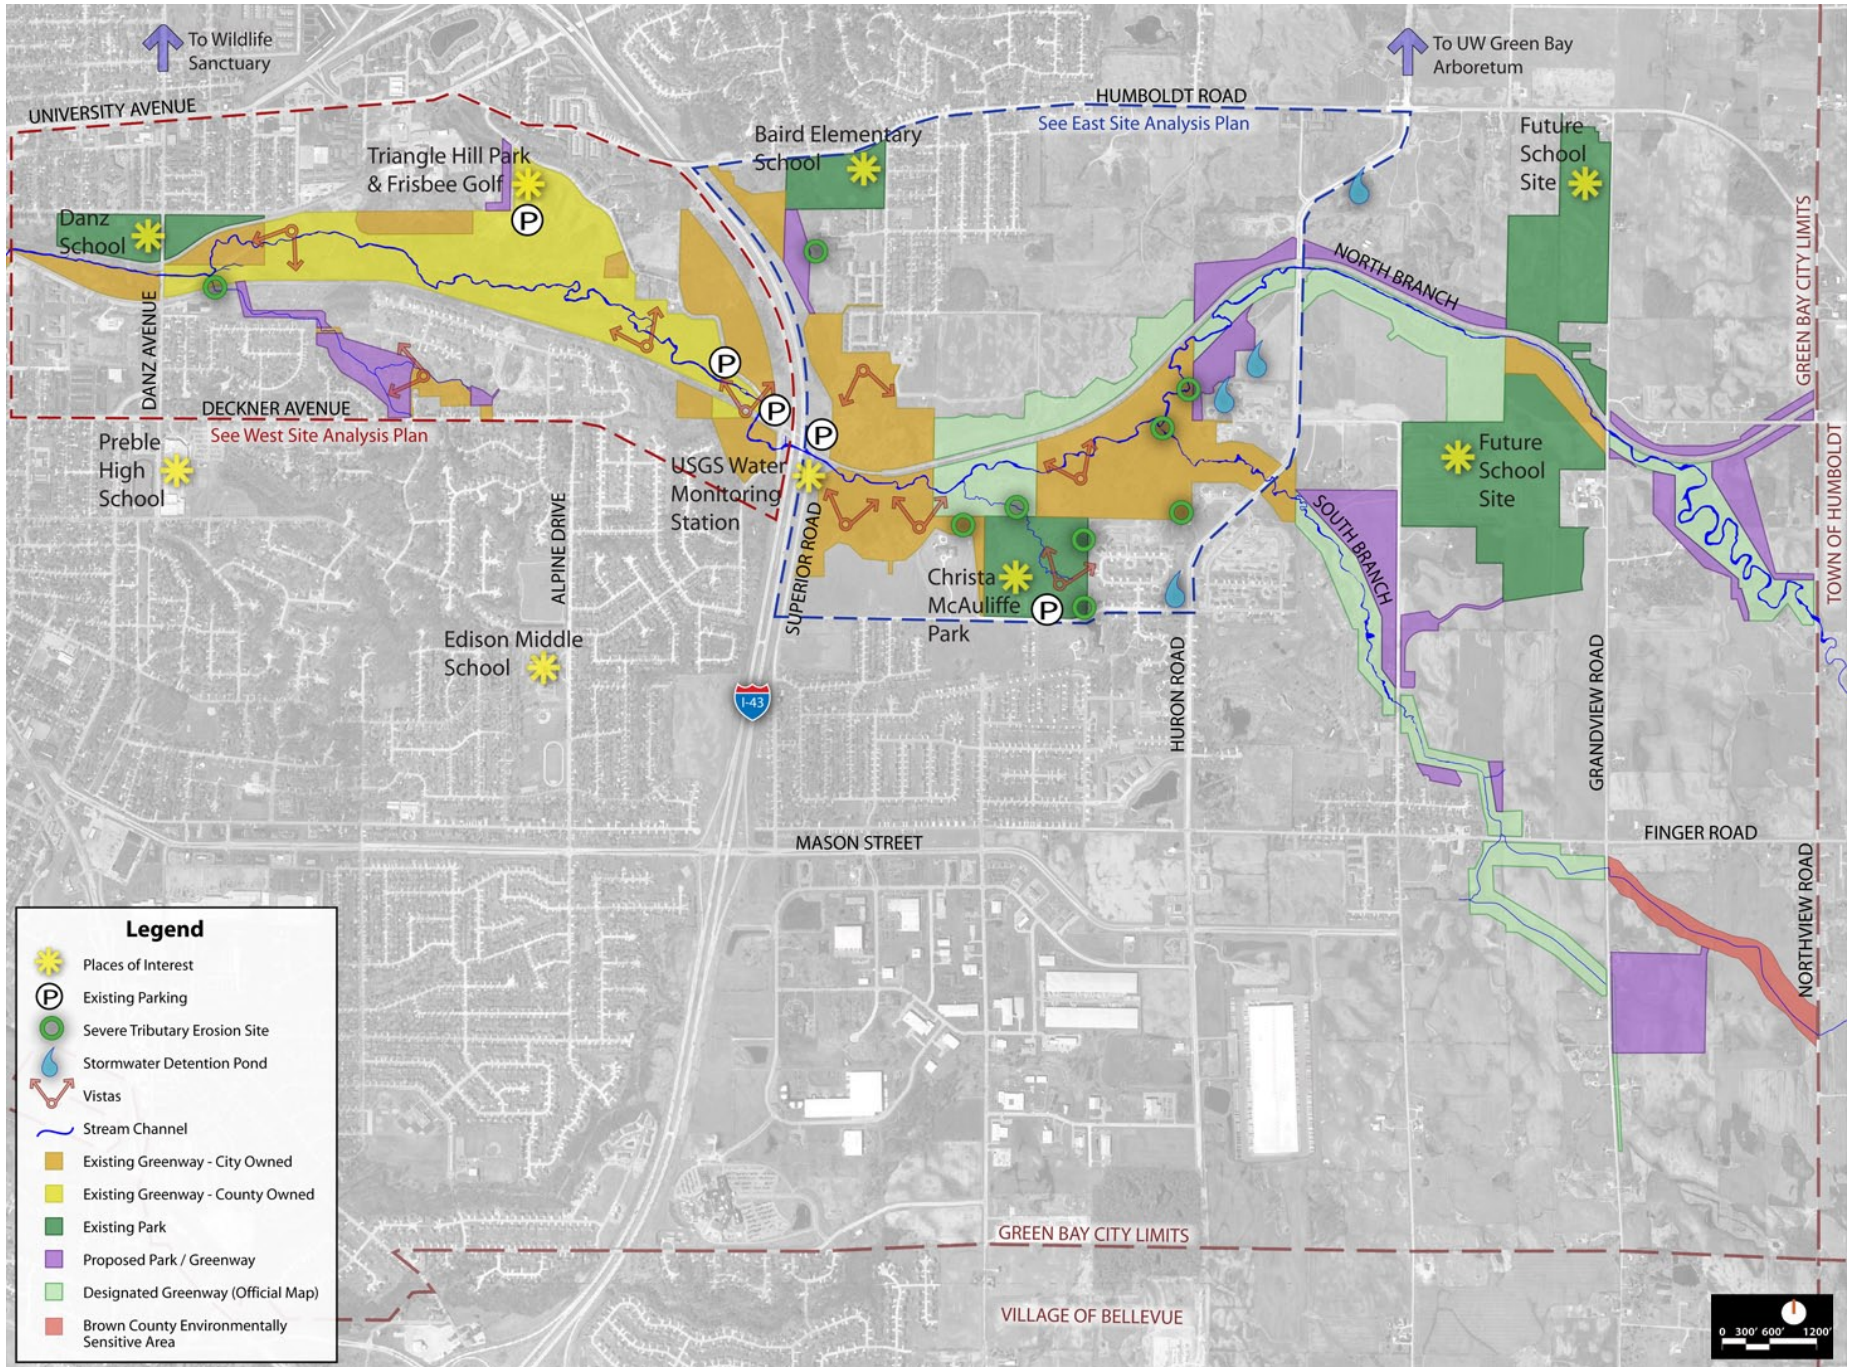
SITE ANALYSIS DIAGRAM, OVERALL

A series of three Site Analysis Diagrams provides a closer view of the Greenway and its physical features. First, the overall view on the facing page shows the Greenway from Berger Street to Northview Road. This graphic illustrates the different ownerships of the Greenway and proposed acquisition or easement areas for Greenway expansion. Expansion areas are listed in two categories: (1) areas currently designated as Greenway on the City's official map, and (2) areas that are proposed additions to the official map. The graphic also shows the main channel of Baird Creek, which splits into the North and South Branches upstream of I-43. Major streets, schools located near the Greenway, parking areas, severe tributary erosion sites, stormwater ponds, and prominent views are also identified.

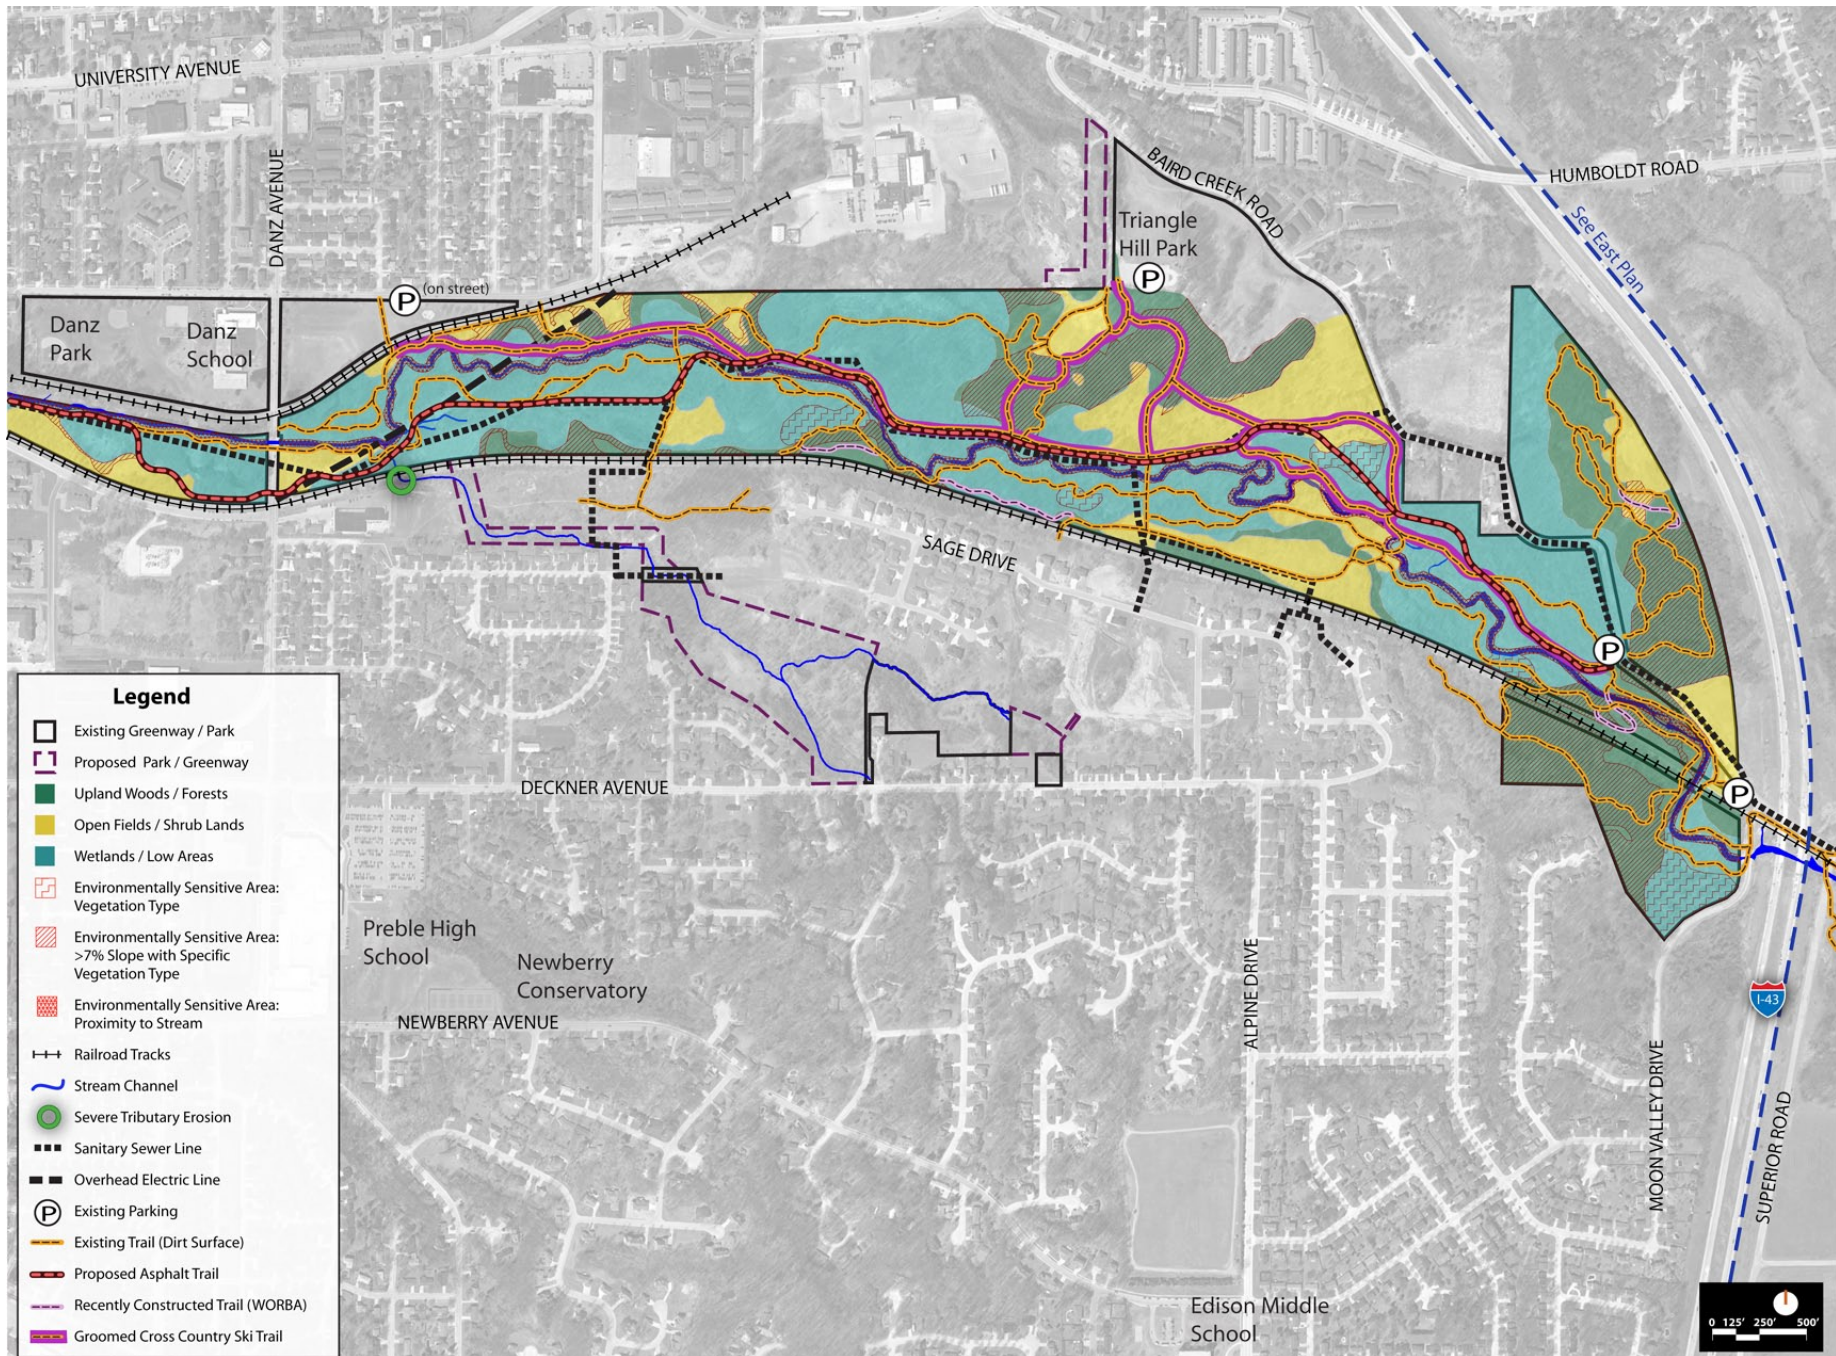
SITE ANALYSIS DIAGRAM, WEST ENLARGEMENT

Site analysis enlargements of Danz Avenue to I-43 and I-43 to Huron Road are provided on the following pages. These diagrams graphically portray more detailed physical characteristics of the Greenway, including:

- General habitat types identified by the 2003 Baird Creek Greenway Ecological Assessment and Management Plan
- Environmentally sensitive areas
- Existing utilities within the Greenway
- Railroad corridors
- Parking areas
- Existing trails identified by WORBA, including recent trail realignments
- Cross country ski trails
- The proposed multi-use trail alignment from Danz Avenue to I-43

The 2003 ecological assessment identified 17 different plant communities located in the Baird Creek Greenway, categorized into three general types: (1) upland woods/forests, (2) wetlands/low areas, and (3) open fields/shrub lands. The site analysis enlargements show the locations of each of these three general habitat types. Specific communities included under the upland woods/forest designation are northern dry-mesic forest, oak openings/woodlands, young disturbed woods, mesic forest, hemlock relict, and mesic white cedar forest. Wetland/low area communities include floodplain forest, young low disturbed woods, wet white cedar forest, stream terrace wet-mesic forest, seep wetland, sedge meadow, and degraded wetland.

weeks. The second railroad corridor bordering the Greenway is a spur that serves Packerland Packing. The track runs between Danz School and the Greenway as shown on the west enlargement.

Several parking areas are located within the Greenway. On the west enlargement, on-street parking is available at Basten Street near Danz School. Three paved parking lots are also located off of Baird Creek Road, including a lot at Triangle Hill Park and Frisbee Golf Course that accommodates approximately 80 vehicles, a centrally located lot that holds approximately 20 cars, and one pull-through lot near I-43 that provides space for approximately 6 vehicles. On the east enlargement, a small, unpaved parking area is available at the intersection of Superior and Baird Creek Roads that accommodates approximately 8 cars; a large paved lot located at Christa McAuliffe Park holds approximately 70 vehicles.

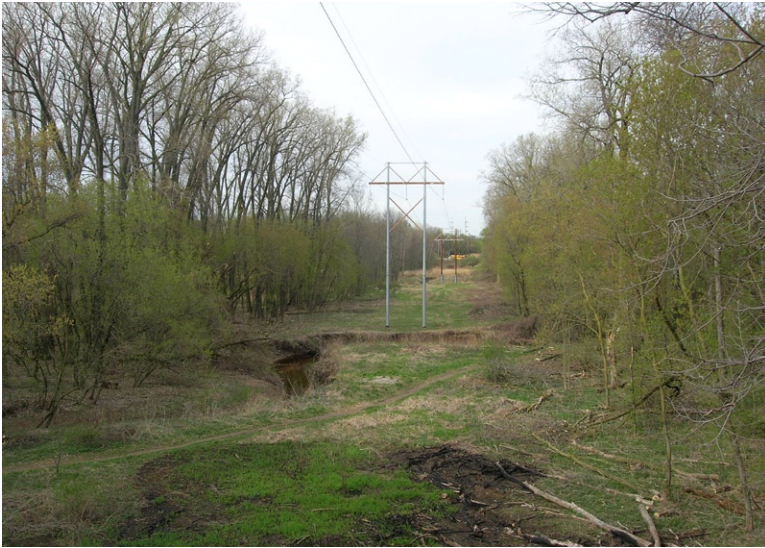
Overhead electric lines near Danz Avenue

Two types of utility corridors are present within the Greenway. A large overhead electric line traverses the Greenway diagonally from Danz Avenue to Clement Street, as shown on the west enlargement. A sanitary sewer main also follows the stream corridor for the length of the Greenway, continuing along the North Branch to Huron Road. Several lateral lines branch off the main, providing easements that could also be used as pedestrian access points.

Utility lines located within the Greenway will constrain habitat restoration efforts. The BCPF will need to work with the owner of the overhead electric line near Danz Avenue to establish vegetative management strategies that will control invasive species and encourage a native herbaceous layer to flourish. The utility should stabilize the base of their poles to prevent erosion that has occurred in the past. Service to the sanitary sewer main running along the creek should also be coordinated to limit its effects on the ecological communities.

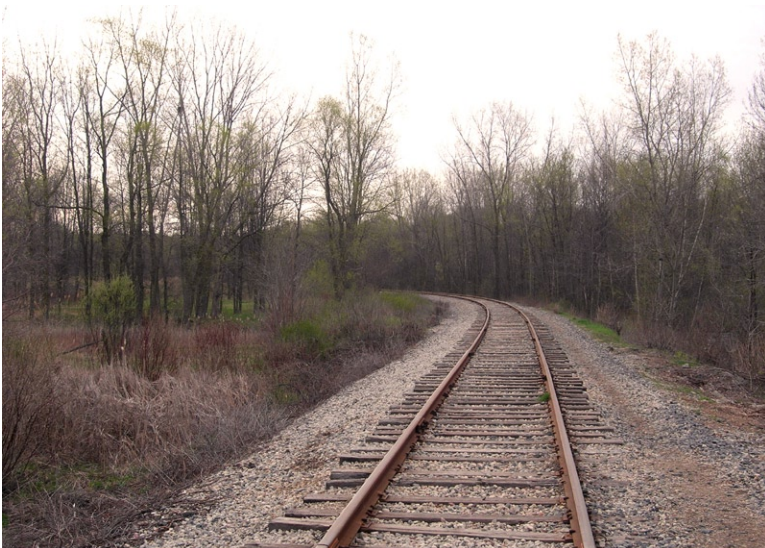
Canadian National Railway corridor east of I-43

Two railroad corridors are also located within the Baird Creek valley. Canadian National Railway owns a railroad line that runs from Green Bay east to Luxemburg. This line runs along the southern boundary of the Greenway from Berger Street east to I-43, and bisects the existing and proposed Greenway from I-43 east to Grandview Road. Railroad service on this tract runs approximately once every two

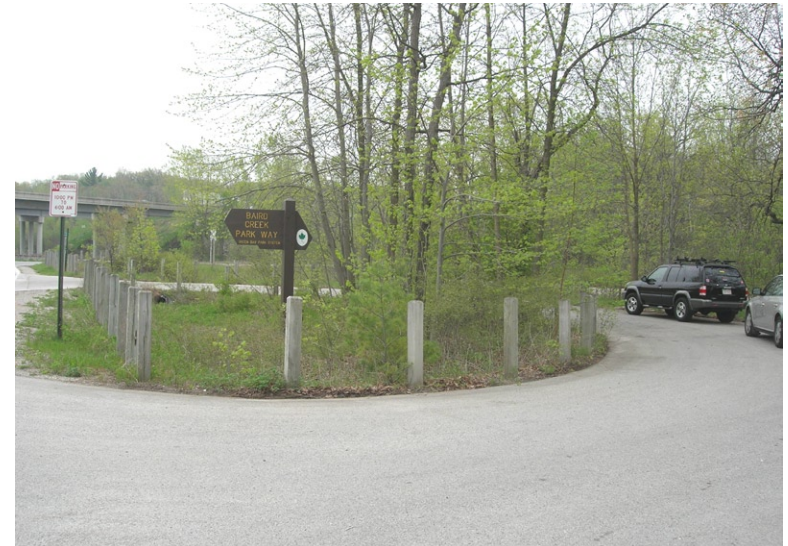
Pull-through parking lot west of I-43 on Baird Creek Road

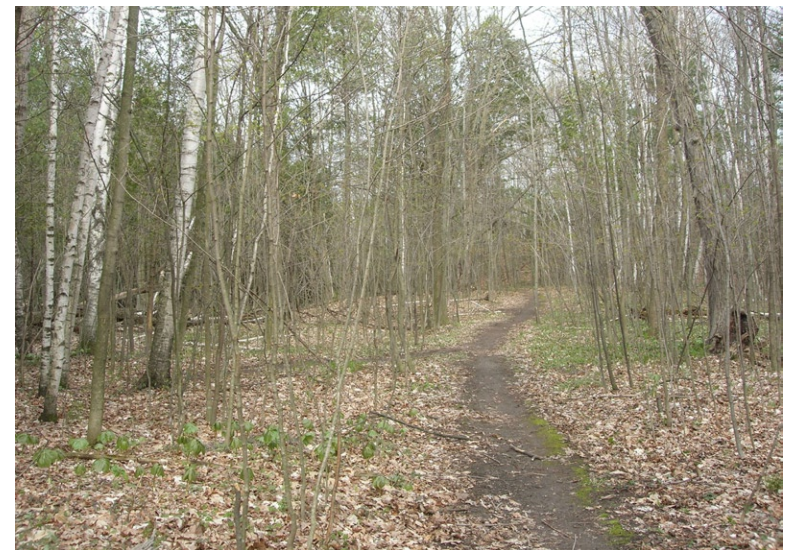
Example of existing dirt-surfaced trail

Existing trails shown on the enlargement plans are generally unimproved and dirt-surfaced. Locations of existing trails were identified by WORBA, including recent work that the organization has completed to realign and/or close trails in poor condition. Cross country ski trail routes and the proposed multi-use asphalt trail alignment were provided by the City of Green Bay. Ski trails are located west of I-43, and are groomed in winter as weather permits. The multi-use trail is currently being designed by the Parks Department, and will provide an alternative transportation corridor from I-43 to downtown. A bridge will be constructed along this trail route to cross Baird Creek. The City envisions extending this trail to Huron Road within the next 5 to 10 years.

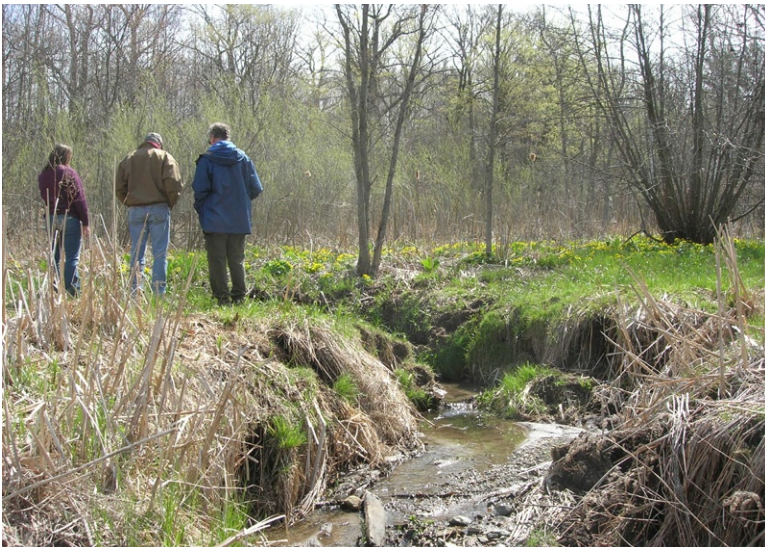
Potential demonstration site: Tributary erosion

In addition to the tributary erosion demonstration sites, all other locations of active, severe erosion on Baird Creek and its tributaries should be remediated on a near-term basis. These sites are especially prevalent east of I-43, along steep tributaries on the Greenway's southern border.

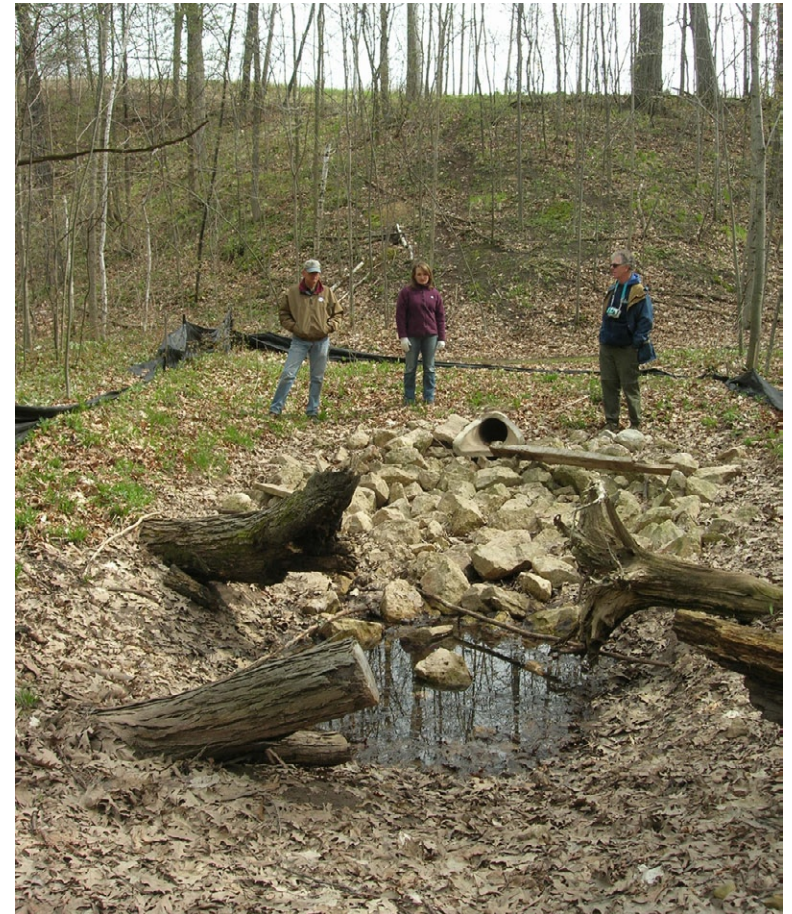
Potential demonstration site: Stormwater basin outfall

The diagrams also identify demonstration sites that could be established in the near future to educate Greenway users on various ecological subjects. In general, these demonstration sites are located near high-use areas such as current access points or highly used trails, and would provide research areas to explore experimental restoration strategies. Topics include stabilizing tributary erosion, removing garbage, restoring sedge meadows, controlling *Phragmites australis*, restoring prairie, controlling stormwater, and restoring trails through wetland areas.

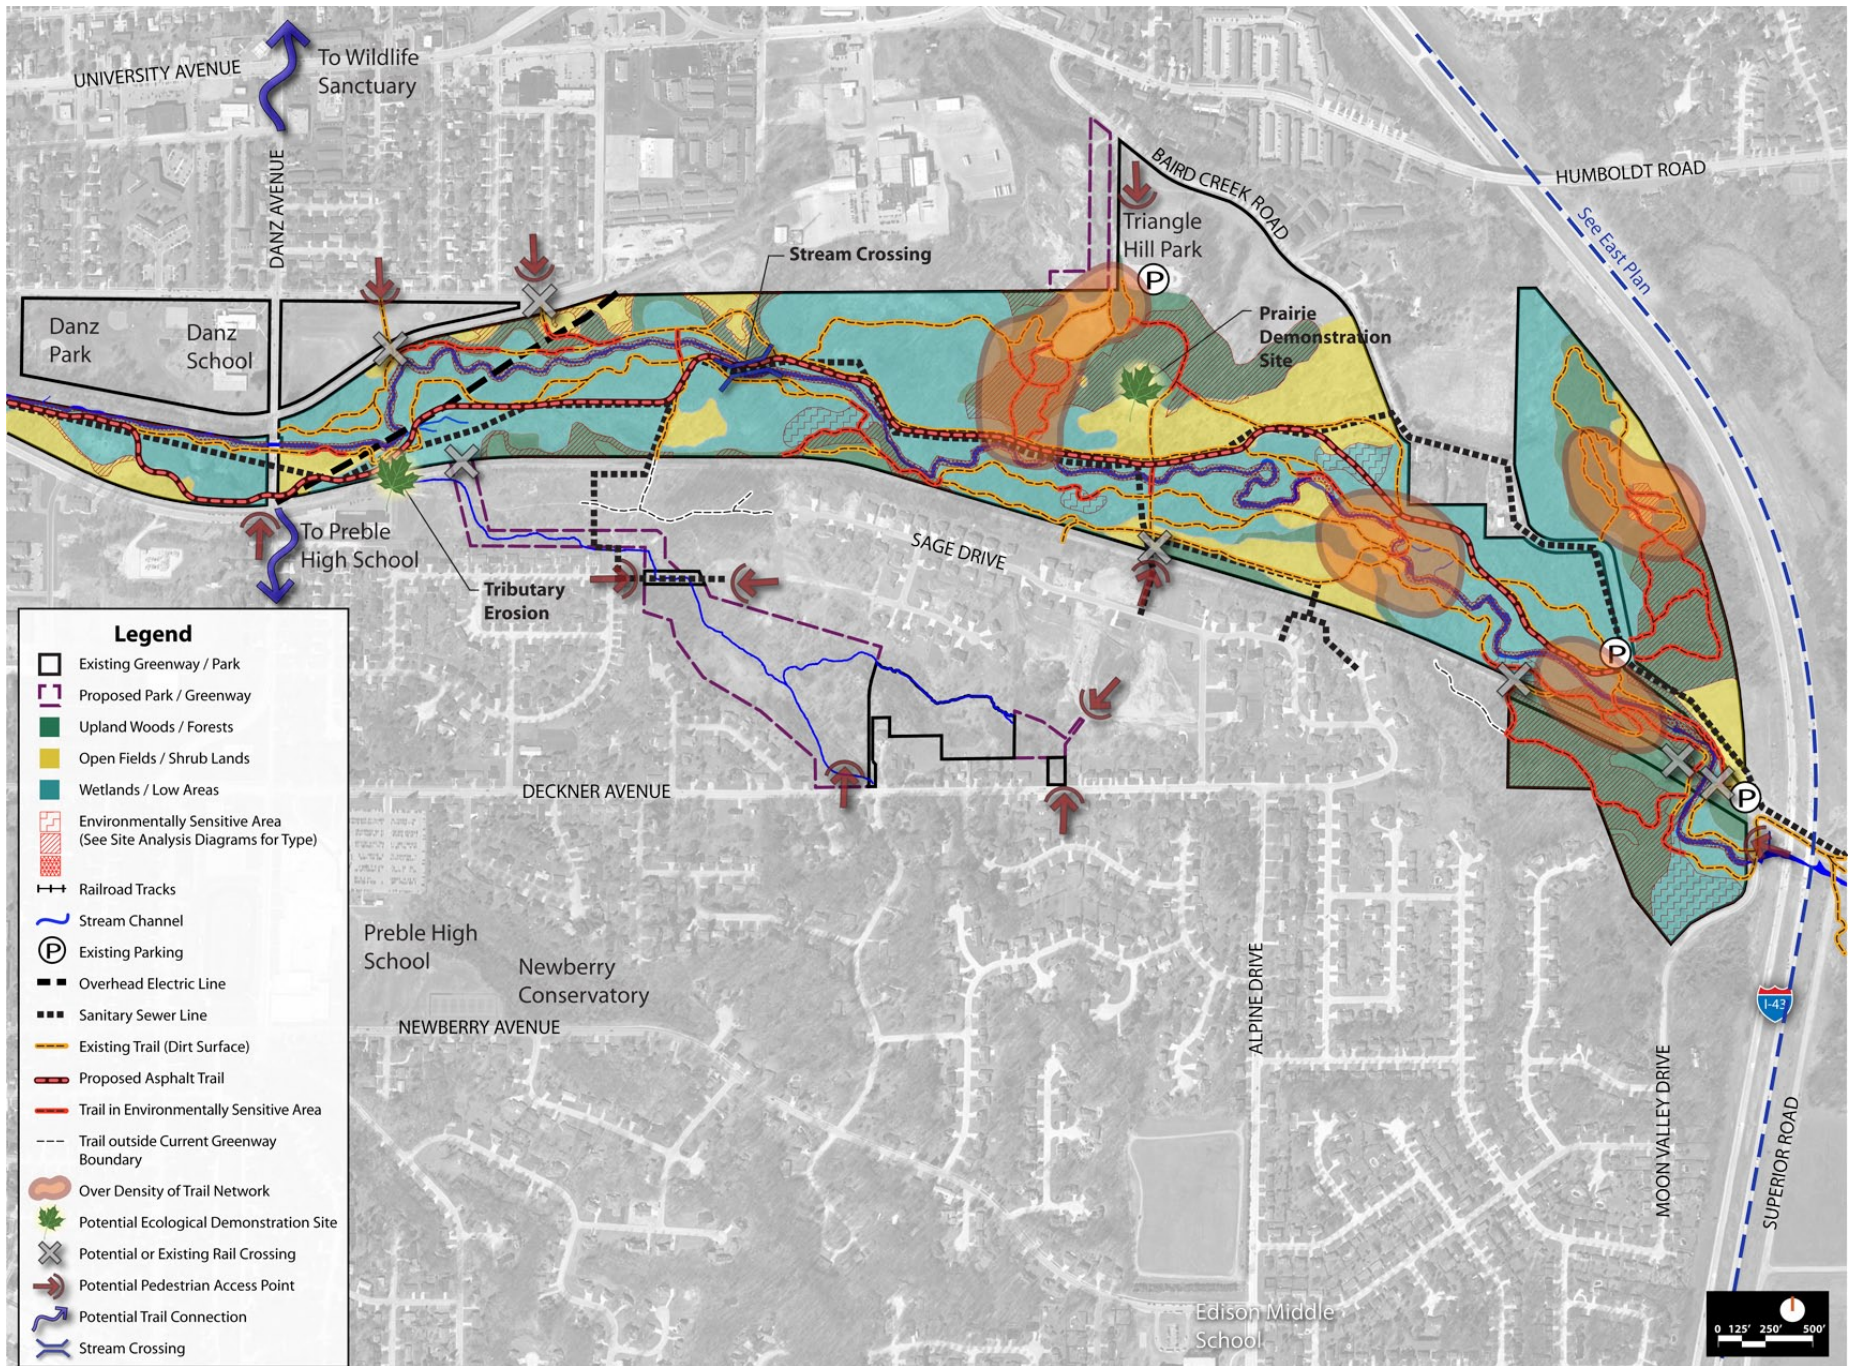
ENVIRONMENTAL FRAMEWORK DIAGRAM, WEST

The Environmental Framework Diagram expands upon the Regional Context and Site Analysis to identify opportunities and constraints for locating program elements within the Baird Creek Greenway. This diagram is split into two sections on the following pages: Danz Avenue to I-43 and I-43 to Huron Road.

First, the diagrams show conflicts along existing trails with ESAs and Greenway boundaries. Trail segments located within ESAs are highlighted in red on the diagrams, and trails outside areas currently under City or County ownership are identified in white. Areas with overly dense networks of trails are also highlighted on the maps.

Existing parking areas and potential pedestrian access points by easements or from existing roadways are identified. Existing or potential trail railroad crossings are also noted. Any improvements at these crossings will require coordination with Canadian National Railway.

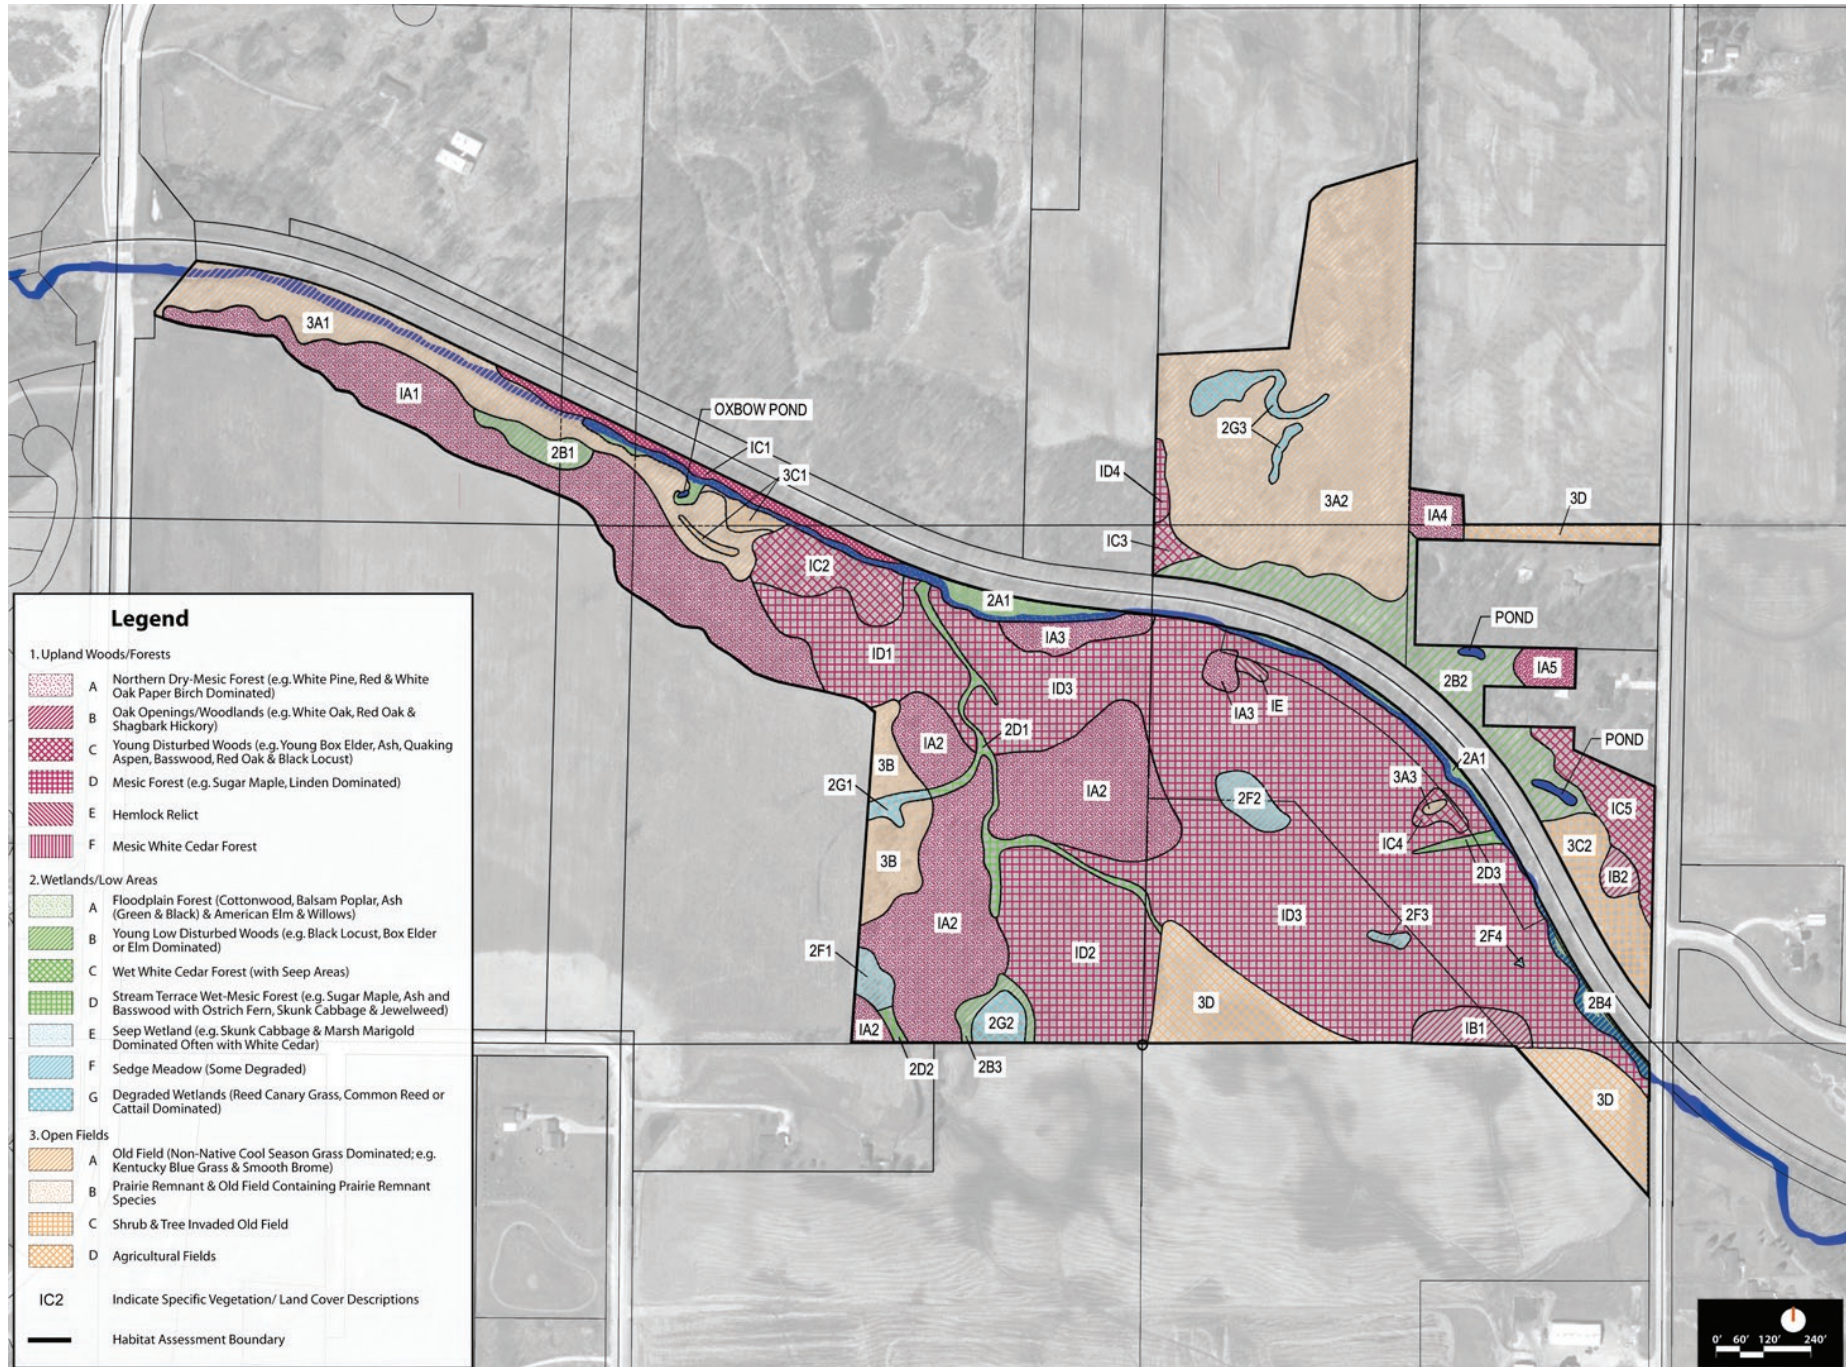
HABITAT ASSESSMENT DIAGRAM, HURON TO GRANDVIEW ROAD

The final component of the analysis of site opportunities and constraints was an update of the Baird Creek Greenway Ecological Assessment and Management Plan to include the area along the North Branch of Baird Creek between Huron and Grandview Roads. In June 2006, JJR staff and Gary Baier of the BCPF conducted a site walk to qualitatively assess the plant communities in this area, as compared to the 17 habitat types identified in the previous study. Approximate habitat boundaries were noted on an aerial photo during the walk. The graphic on the facing page shows the types and locations of observed habitats.

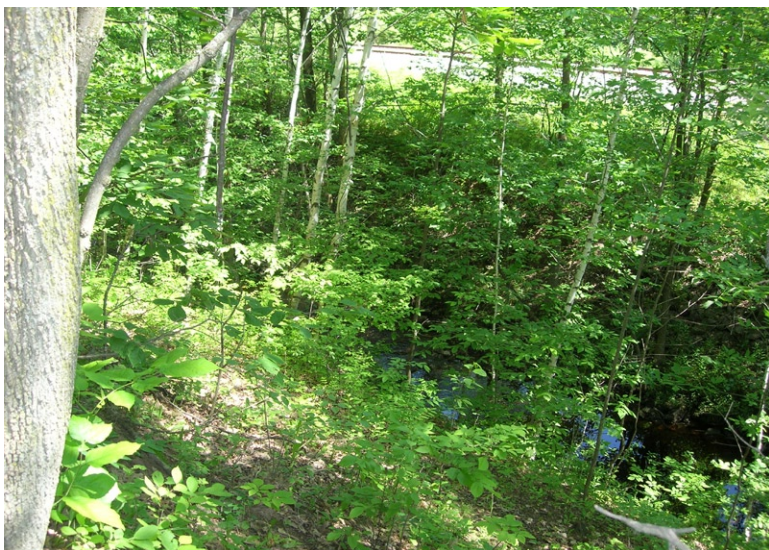
Mesic forest 1D3 along stream, showing depth of old channelization

- 1D1. Mature mesic woodland characterized by a maple and linden canopy.
- 1D2. Mesic woodland including maple, linden, and beech. One lone hemlock tree is located within this zone.
- 1D3. Relatively young mesic woodland dominated primarily by lindens. This zone covers the greatest expanse of wooded area within the assessment area. Along the entire assessment area, the stream was deeply channelized (most likely when the railroad was constructed) resulting in steep slopes on both sides of the channel and minimal floodplain. Birch and aspen are located within this zone on the steep slopes immediately adjacent to the channelized stream. Scattered patches of relatively young buckthorn exist generally close to the stream channel. Also within this

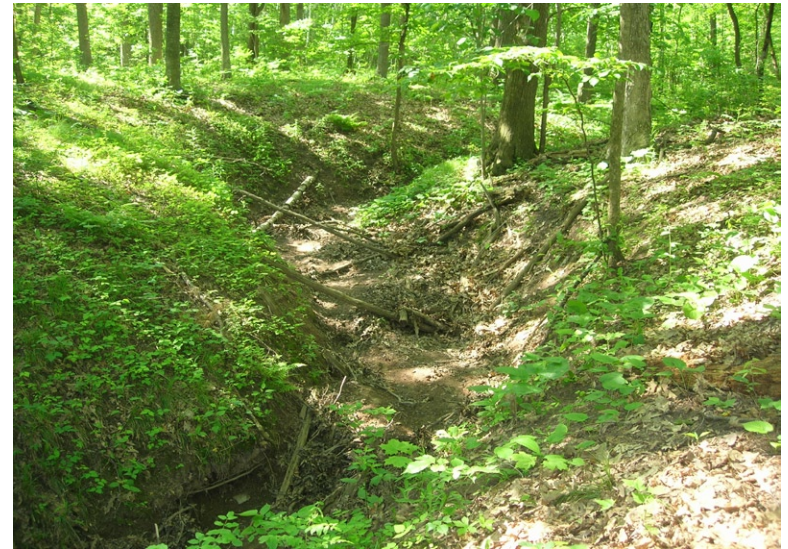
Stream terrace habitat 2D1, characteristic of upper channel reaches

- 2D1. Large drainage channel network extending through site. Lower end of channel has extensive semi-shaded sedge meadow complexes with standing water. Upper reaches of channels are eroded ravines with little vegetation along bottom of channel but quite extensive vegetation present on side slopes. Relatively small stretches of the ravines are actively cutting due to agricultural runoff from adjacent parcels, and have higher degrees of erosion.
- 2D2. Forested drainage channel with standing water. Ash canopy over pool with sedge and iris herbaceous edge.
- 2D3. Wider drainage channel similar to upstream characteristics of 2D1.

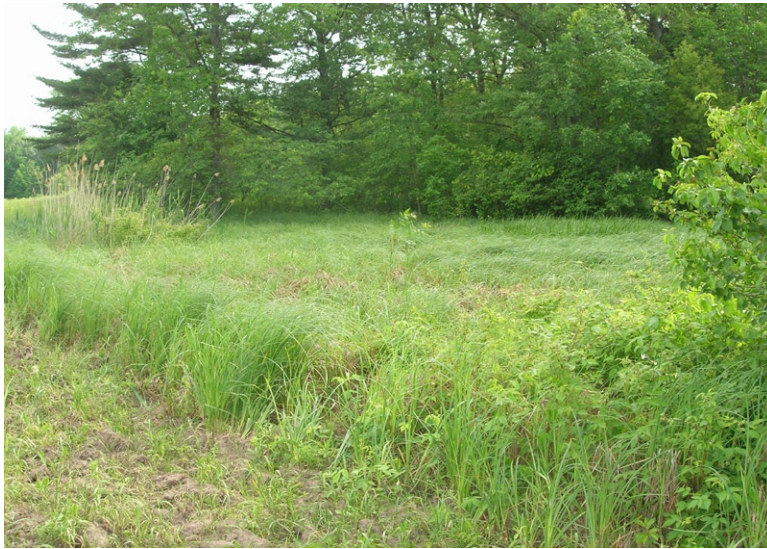
Sedge meadow 2F1, note phragmites invasion

- 2F1. Large sedge meadow on edge of agricultural area. Relatively intact despite agricultural runoff contributions to hydrology. Small phragmites invasion beginning that should be dealt with immediately to remove threat.
- 2F2. High quality, large sedge meadow surrounded by forest.

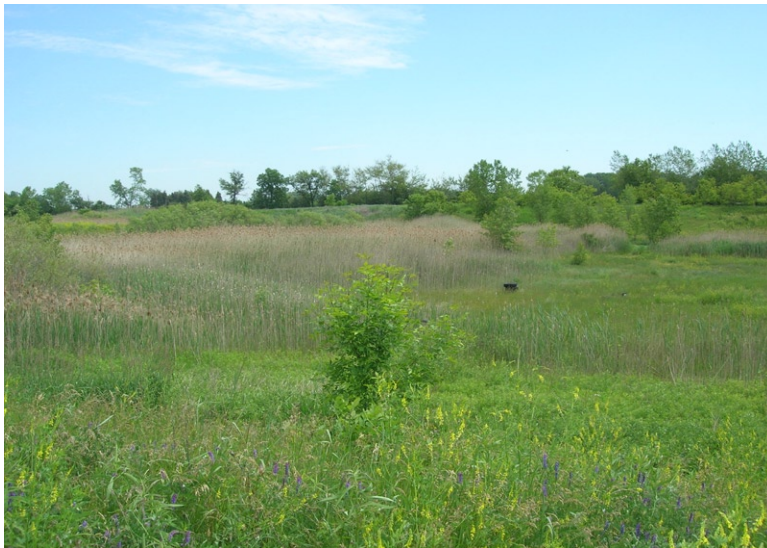
Phragmites-dominated wetlands 2G3 in open old field

- 2G1. Drainage channel through old field dominated by non-native grasses.
- 2G2. Grass and cattail-dominated wetland. This wetland most likely was originally similar to sedge meadow 2F1 or 2F2, with runoff from adjacent agriculture changing the hydrology and community composition.
- 2G3. Phragmites-dominated wetlands within an open field habitat that appears to be an old quarry site.
